05/09/76 Imperial Iranian Air Force (IIAF)

Official Accident Report Index Page

Report Number	NTSS-AAR-78-12
Report Title	Investigation Report--Wing Failure of Boeing 747-131, Near Madrid, Spain, May 9, 1976
Report Date	October 6, 1978
Organization Name	National Transportation Safety Board Bureau of Technology Washington, D. C. 20594
WUN	2479
Sponsor Name	NATIONAL TRANSPORTATION SAFETY BOARD Washington, D. C. 20594
Report Type	Special Investigation Report May 9, 1976
Distribution Status	This document is available to the public through the National Technical Information Service, Springfield, Virginia 22151
Report Class	UNCLASSIFIED
Pg Class	UNCLASSIFIED
Pages	43
Price	H03.A01
Keywords	Aircraft accident; lightning strike; explosion; fuel flammability; wing failure; gust overload; fuel ignition.
Abstract	On May 9, 1976, an Imperial Iranian Air Force Boeing 747-131 crashed as it approached Madrid, Spain. Witnesses observed lightning strike the aircraft followed by fire, explosion, and separation of the left wing. The report includes fire pattern studies, structural failure descriptions, trajectory analysis, fuel flammability calculations, gust loading analysis, and an analytical treat

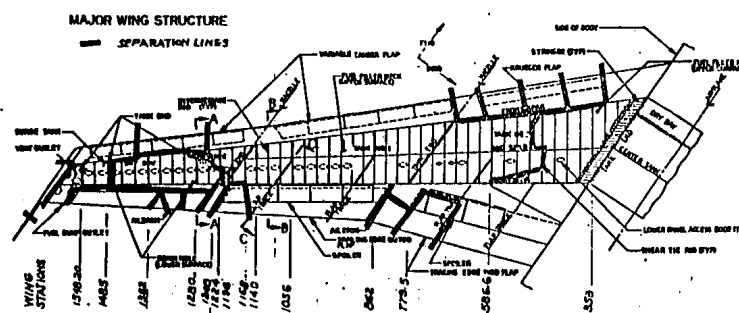
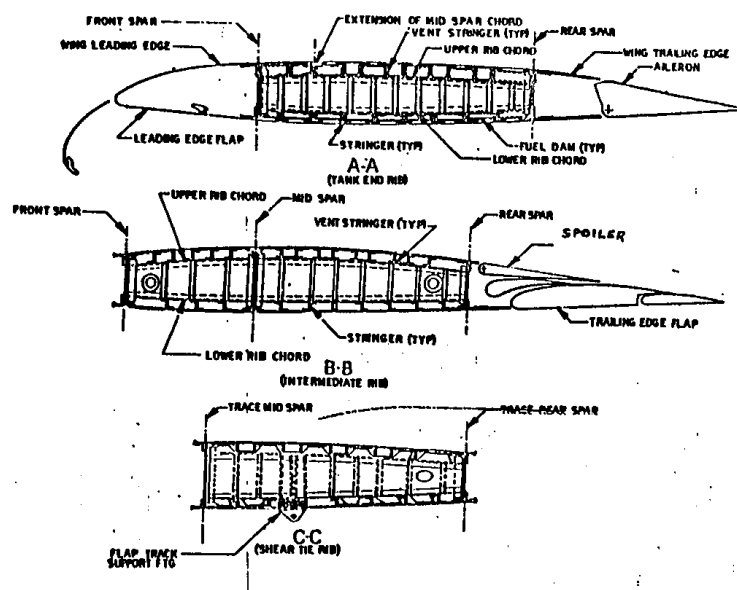
MAJOR WING STRUCTURE

Pitting and localized burn areas typical of lightning attachment damage were found on the left wingtip and on the vertical fin at the VOR antenna. The left wing had separated into 15 major pieces before ground impact and parts of it were found at each location of wreckage. (See drawing on page 31.)

The left wing outboard of the No. 1 engine position separated in three major pieces and along three lines of fracture. The left wingtip, a piece about 20 ft long, separated on a line parallel to the fuselage centerline and roughly halfway between the end of the wing and the No. 1 engine. A second line of separation was just outboard of the No. 1 engine and ran parallel to the rib centerlines. The third line of separation spanned between the first two and ran along the front spar. The wingtip, consisting of the high frequency antenna and coupler, also separated from the wing.
